**Effect of
CADWELD Connections
on Galvanized Pipe**

Test No. 53d

ERICO Products, Inc.

OBJECT: To determine the effect of a CADWELD Connection on galvanized fence post, both inside and outside surfaces with the outside both unprotected and protected with a zinc rich paint.

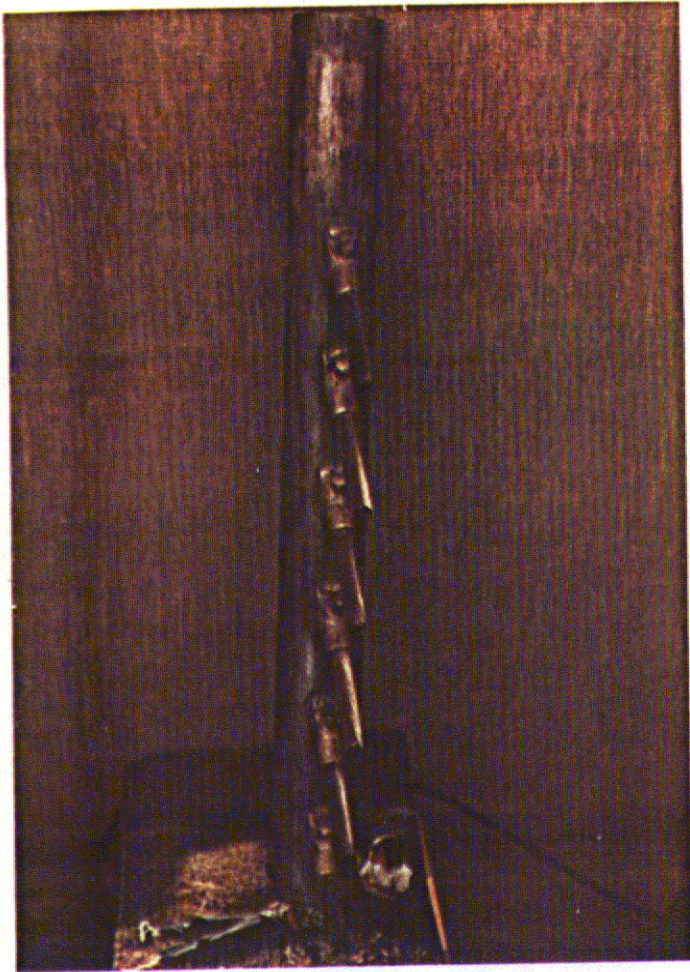
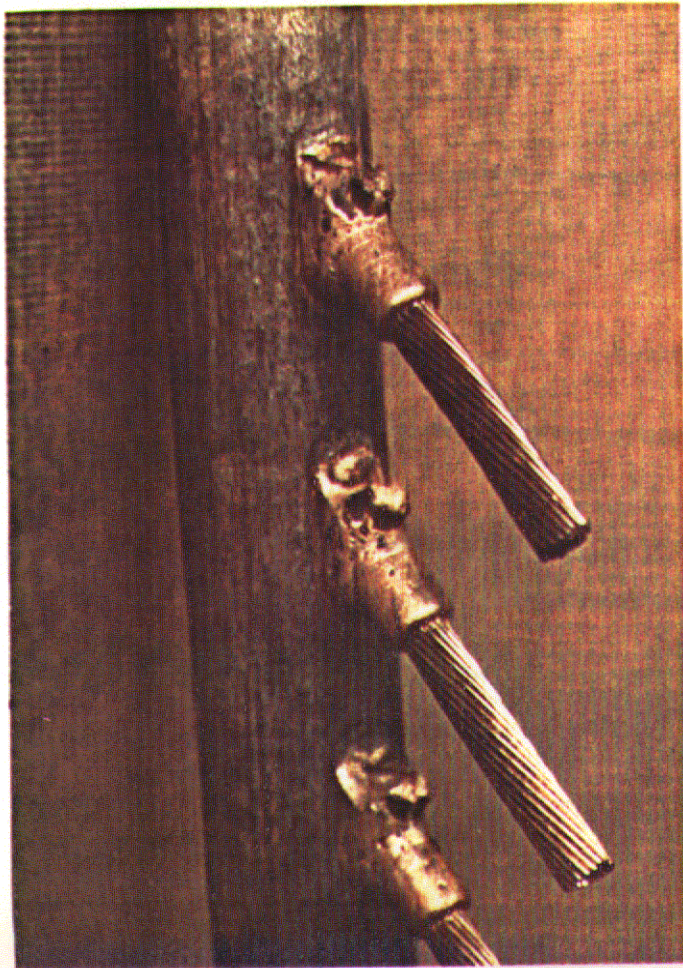
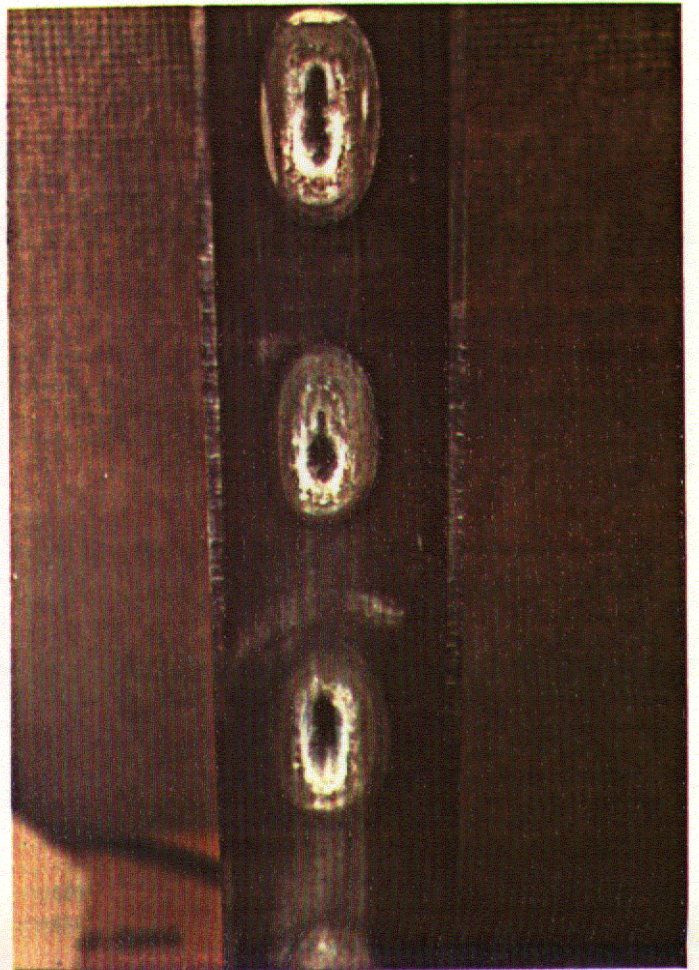
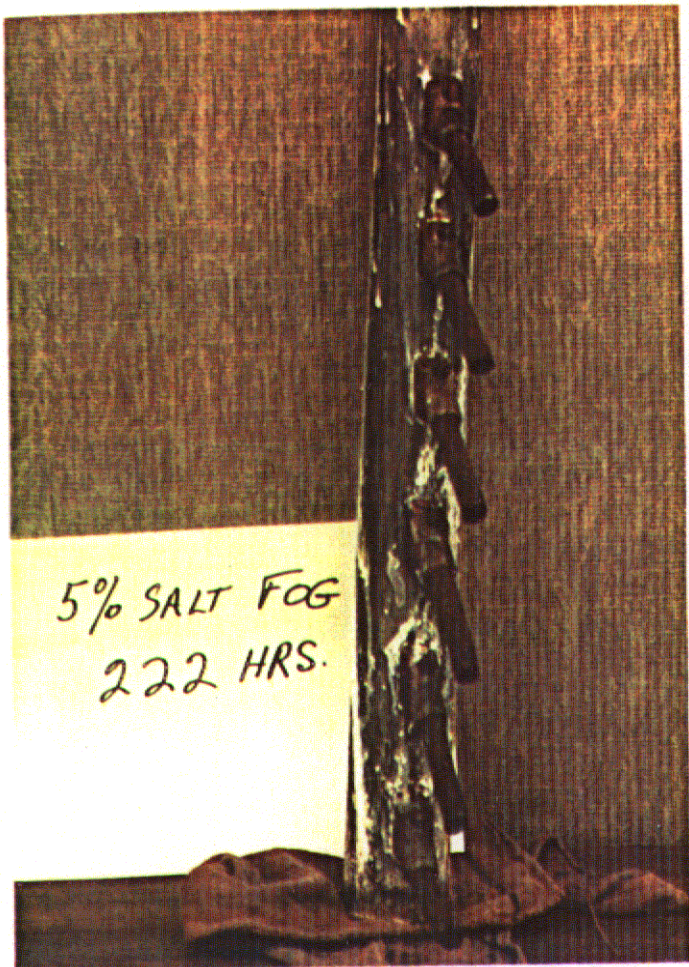
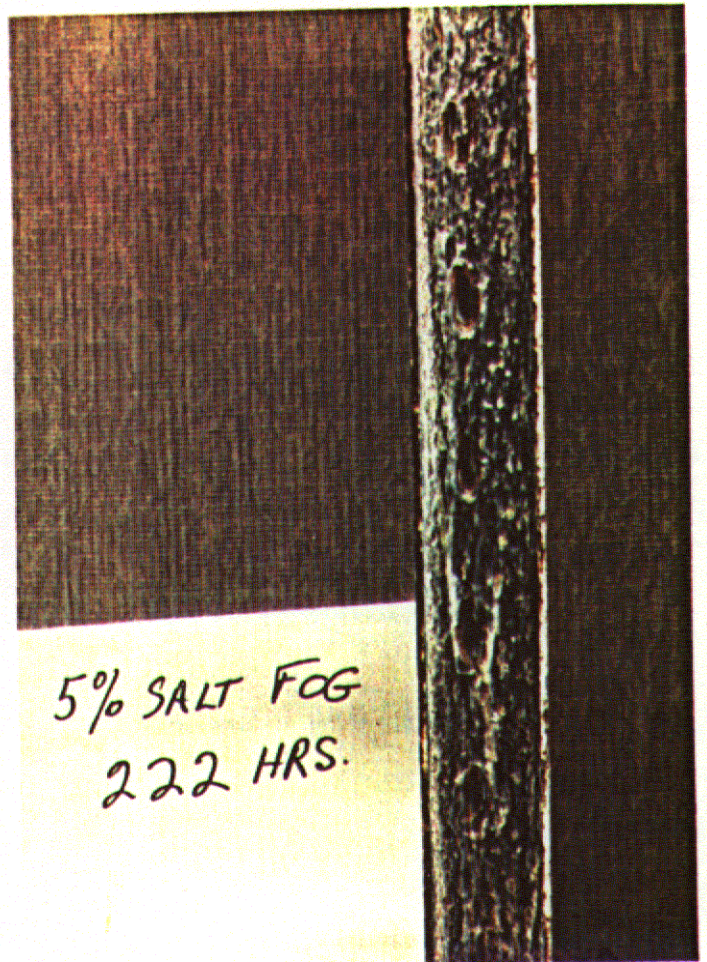
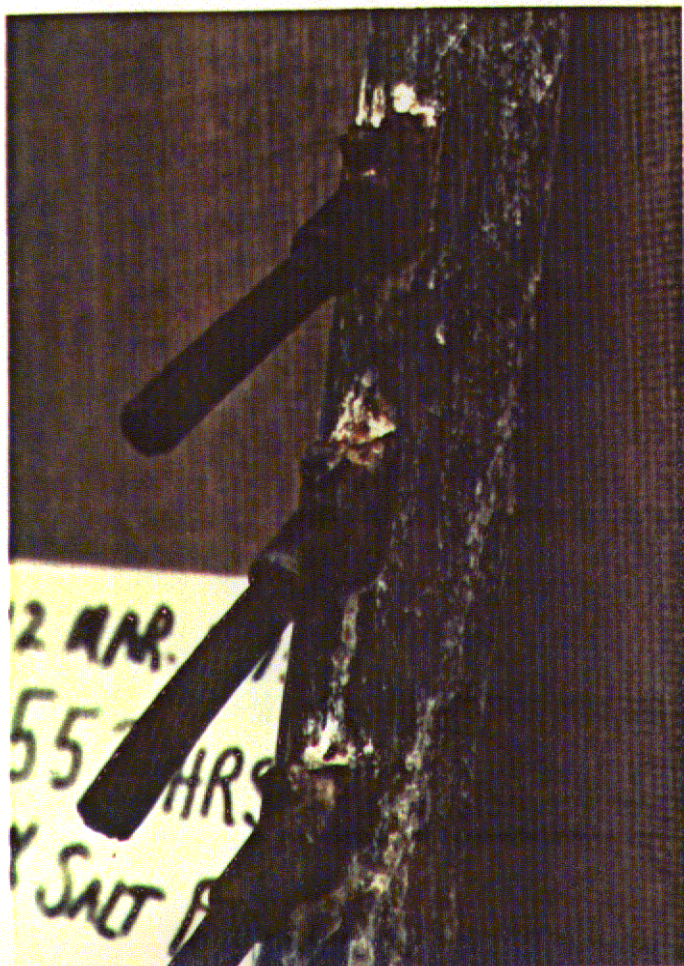
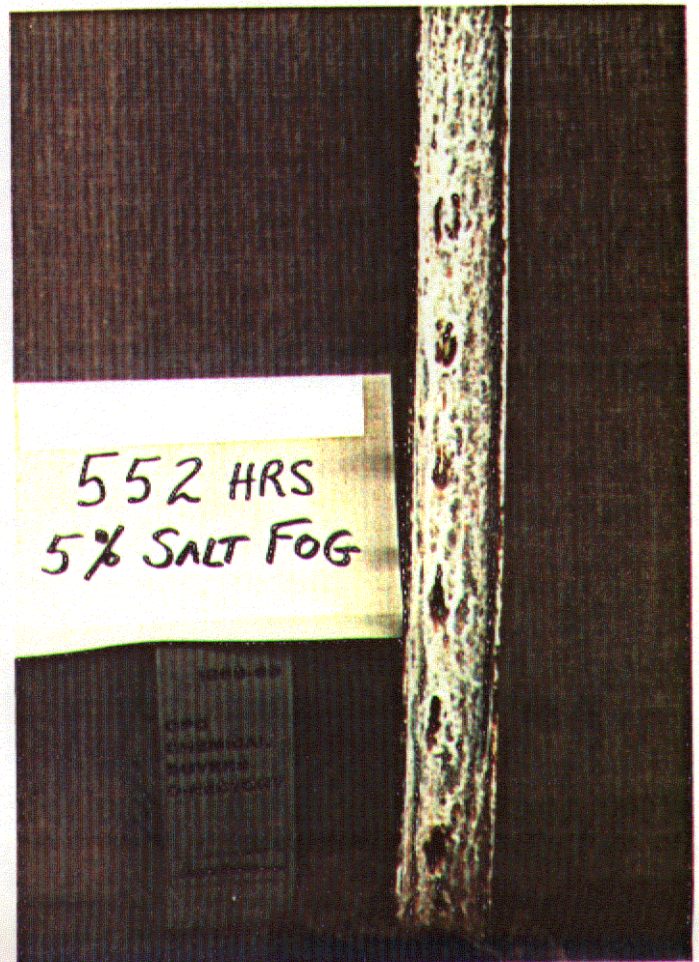
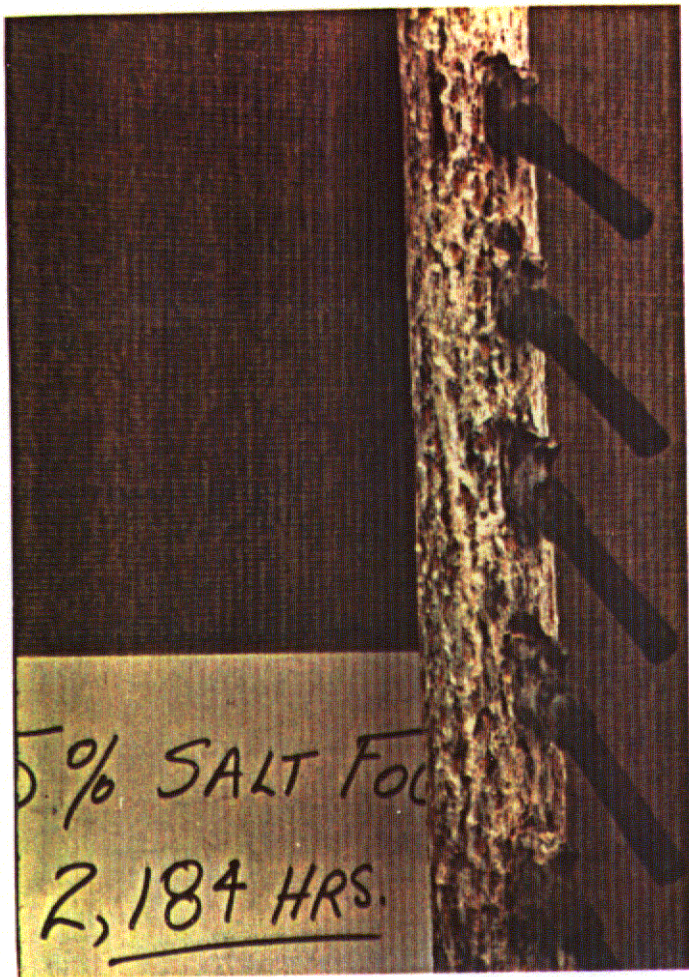
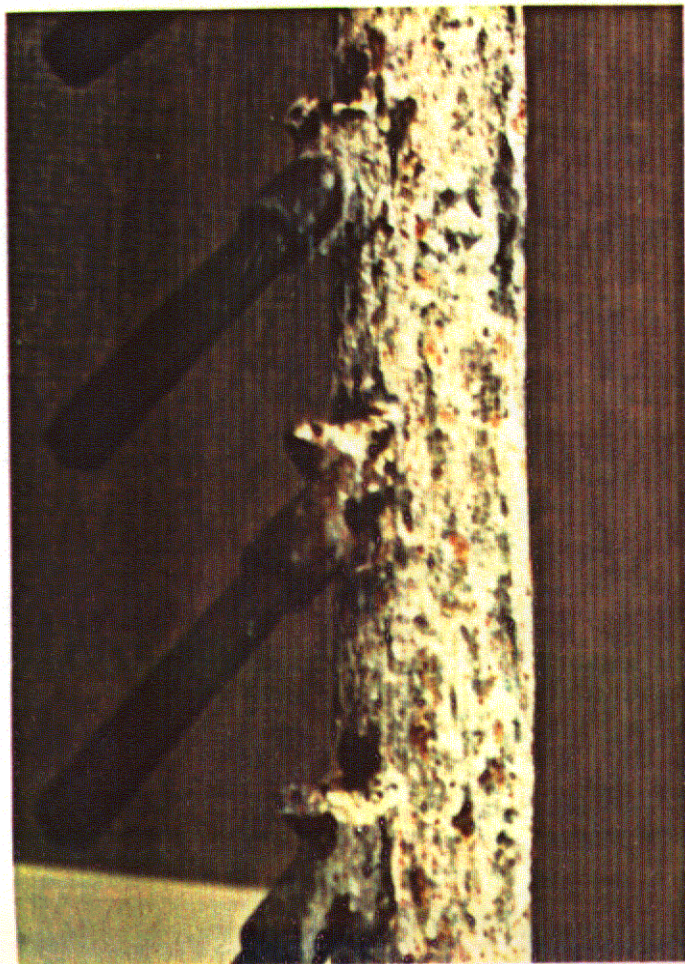
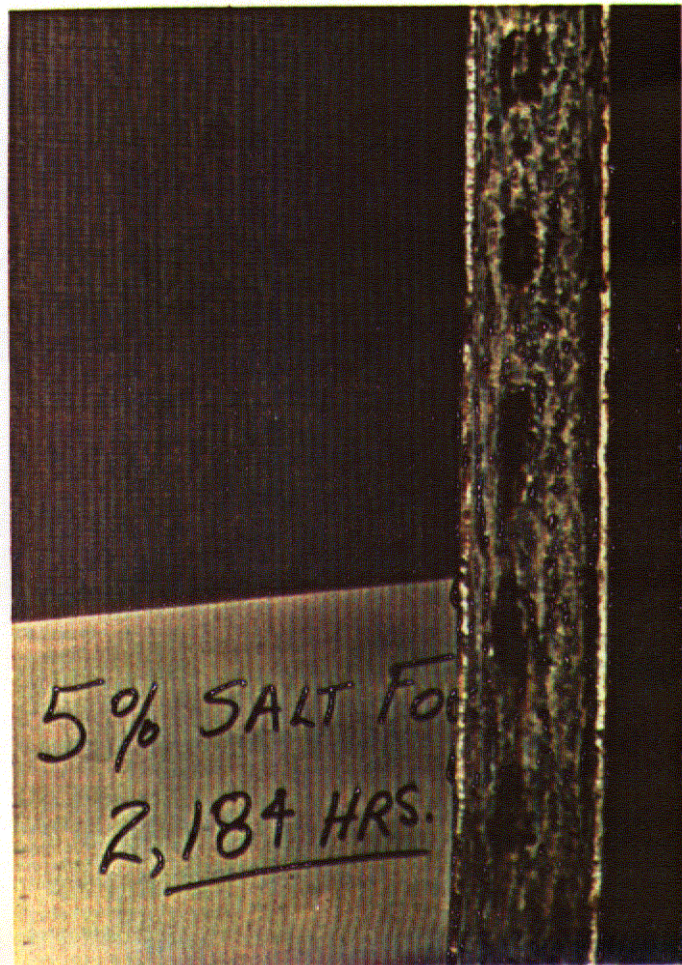
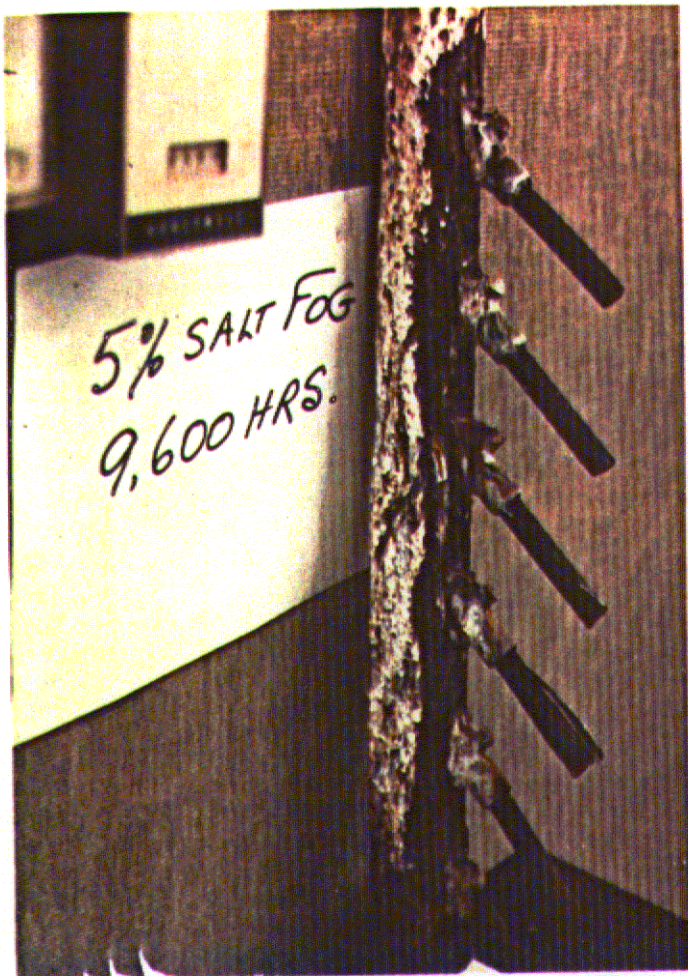
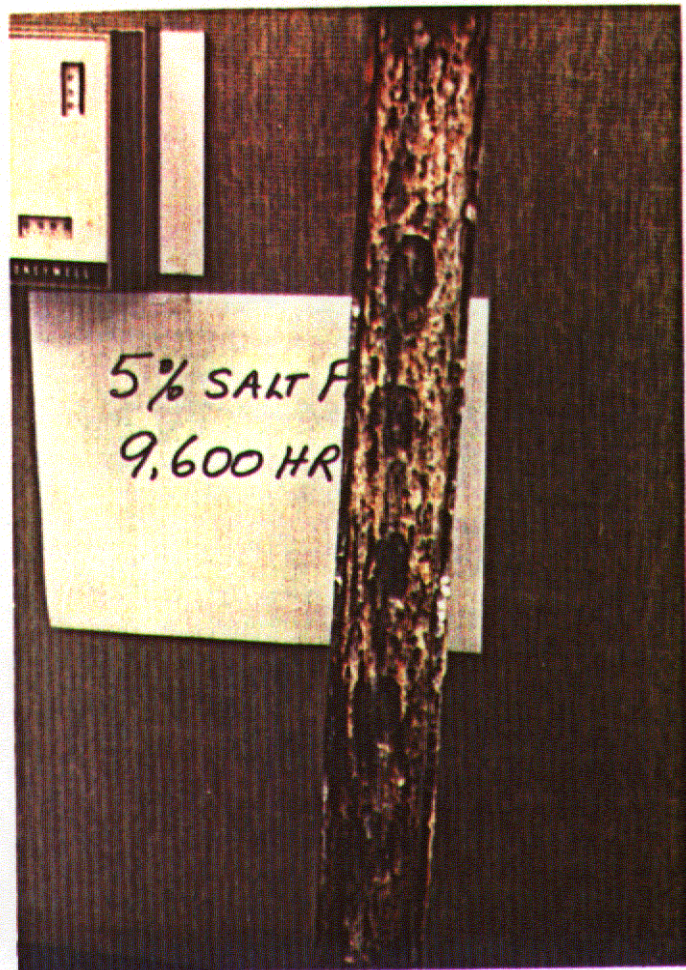
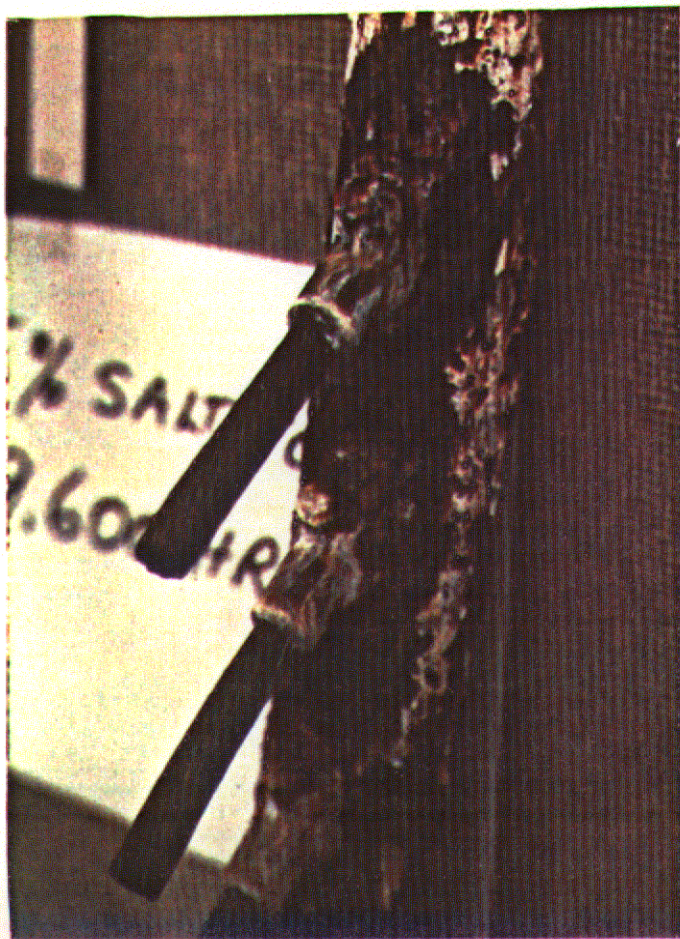
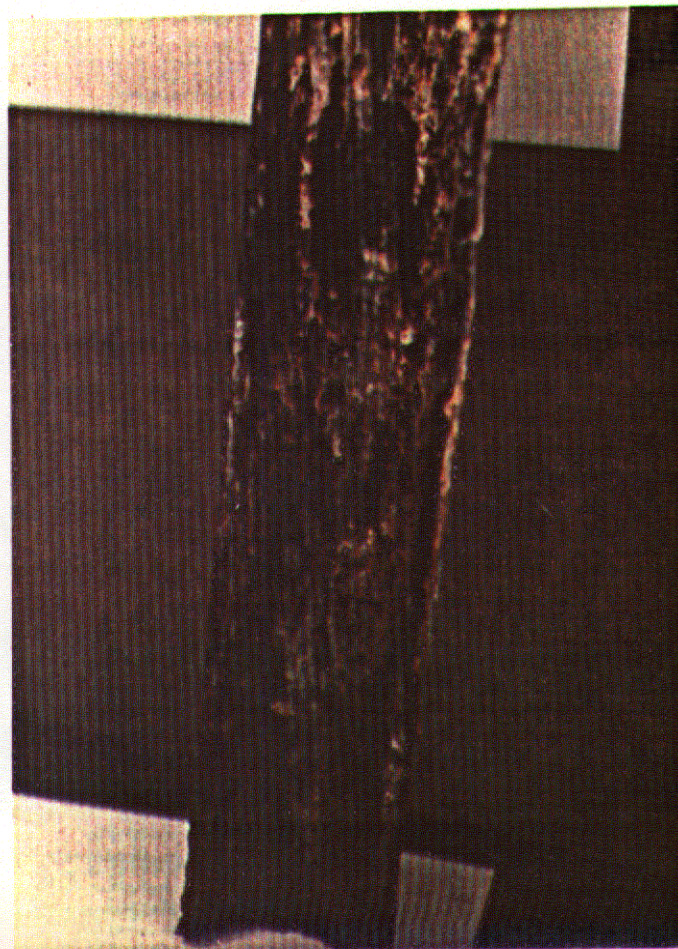
APPENDIX: Attached photos show the set up and the various stages of the test.

METHODS: The sample pipe sections were placed in a salt fog chamber and exposed per ASTM B117 (5% salt fog, 100% relative humidity at 95°F) for 9600 hours (13 months) with periodical removal, examination, and photographing.

RESULTS: After 222 hours exposure to the salt fog, no red rust is apparent around either the protected or unprotected welds. The inside of the pipe does show small amounts of red rust directly under each weld.

After 552 hours exposure, very small amount of red rust developed on the outside of the pipe around the unprotected weld. However, no red rust was detected around the protected weld. The amount of rust on the inside varied little from that observed at 222 hours.

After 2184 hours (91 days) exposure, red rust is beginning to show on all portions of the pipe, even those not affected by the weld.

After 9600 hours, severe overall corrosion has taken place. However, close examination revealed the inside surface under the weld was not as deeply pitted and corroded as the outside surfaces. This may have been caused by the positioning of the test sample in the salt fog chamber.
